Beneficially Reusing Dredge Material to Rebuild a Marsh – one year later

- 2013 tidal marsh restoration via thin layer application of dredge material
- Pepper Creek and Piney Point Tract of Assawoman Wildlife Area, Dagsboro, DE
- 47 acres
- 9,000yd³
- raise elevation to 1.05' NAVD88
- address hummocks

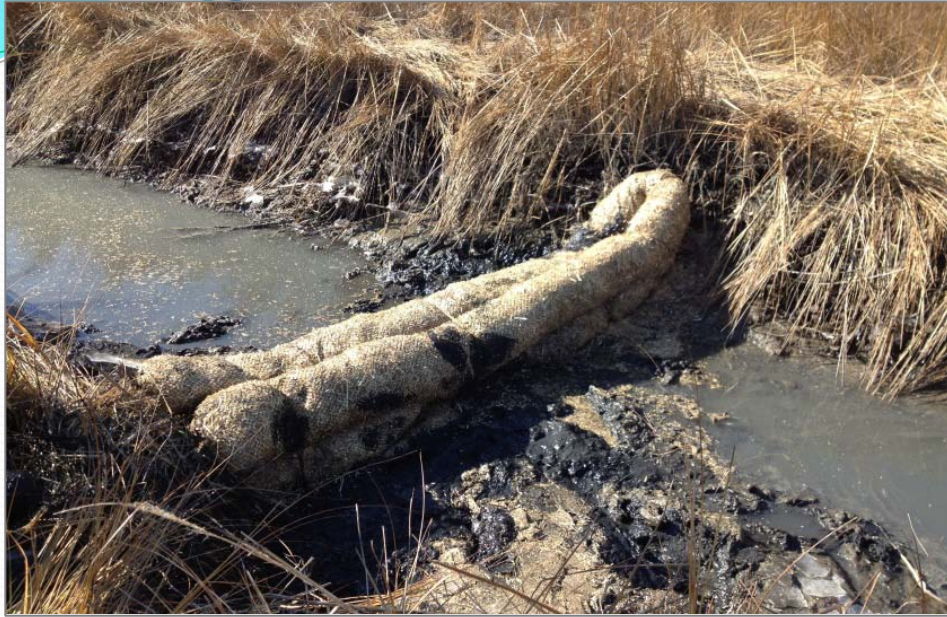
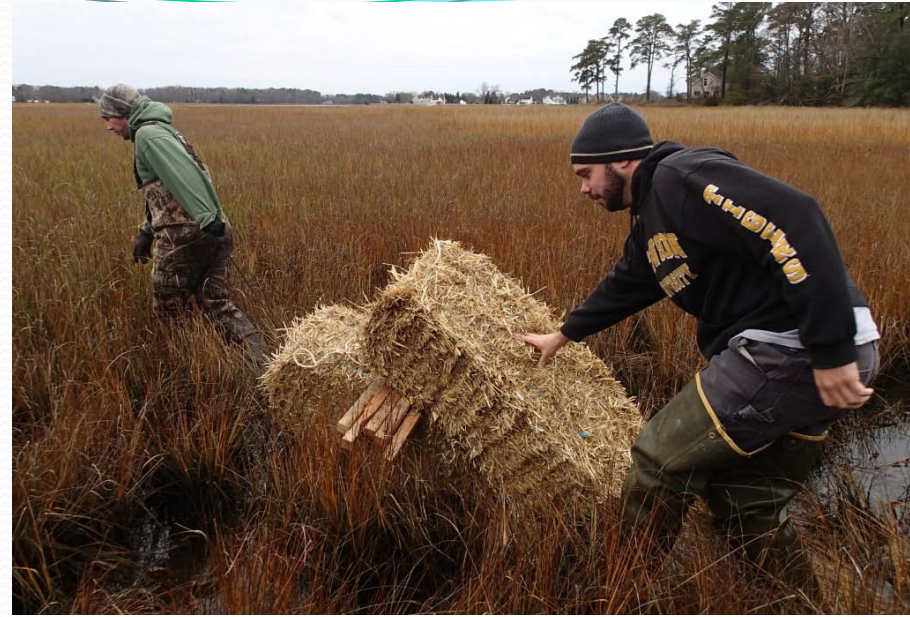
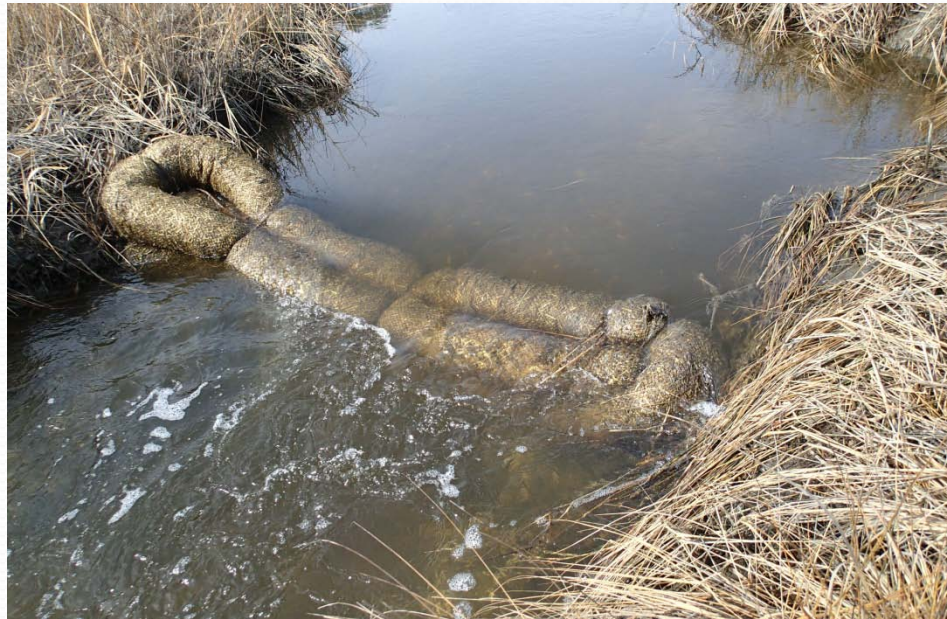
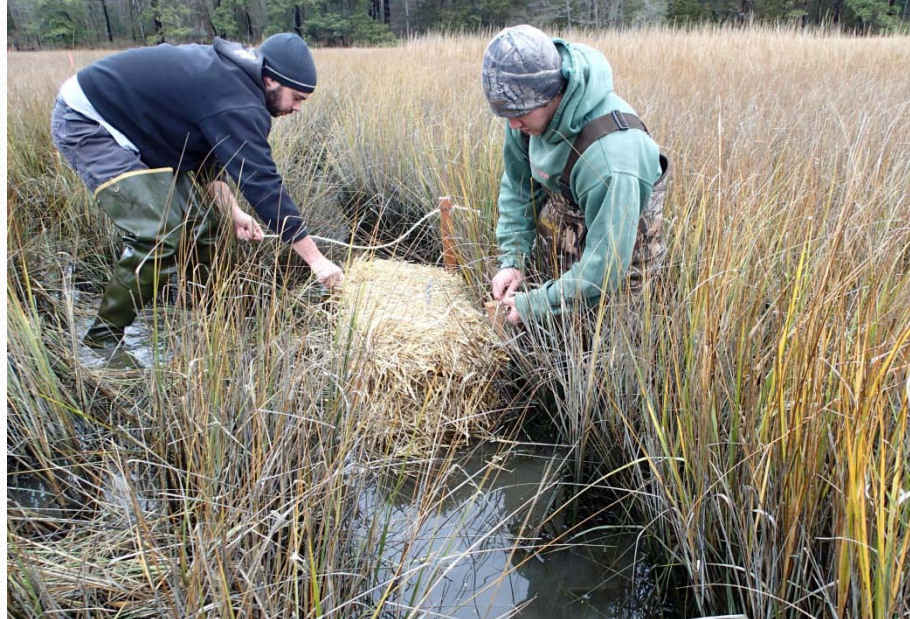
2. Sediment sills: straw bales and waddles

Fall 2014:

Straw waddles from spring were gone;
from Fall were all recovered

No straw bales were recovered

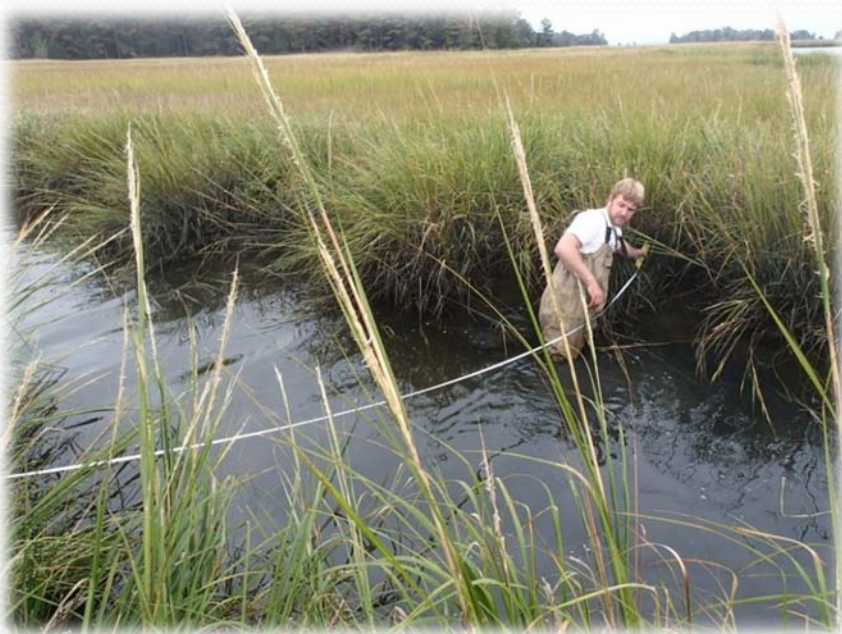
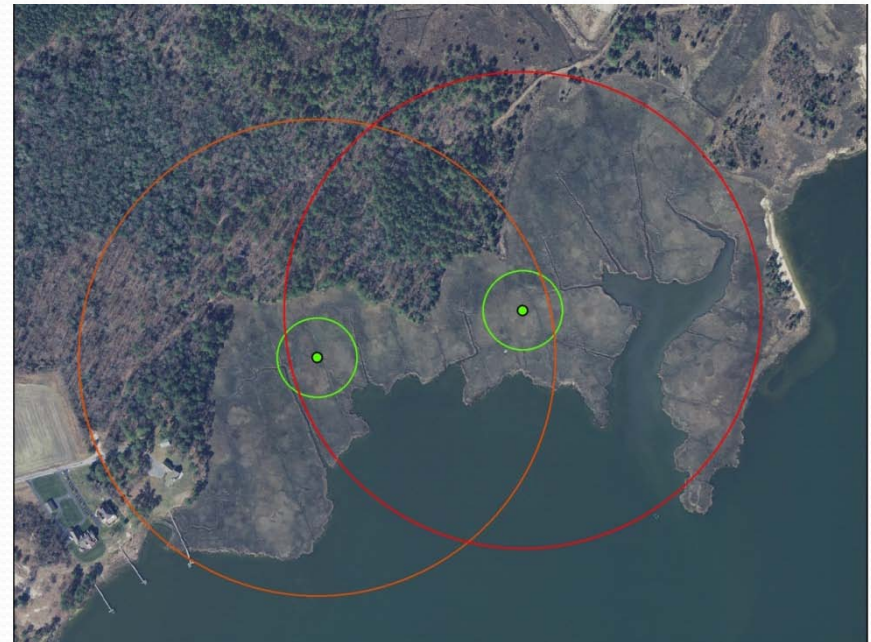
3. Condition Assessments

- using Mid-Atlantic tidal rapid assessment method
- completed once per year July-September
- 2012, 2013, 2014

Slight decrease in Bearing Capacity at both sites

Slight decrease in Horizontal Vegetation Obstruction at continuation site

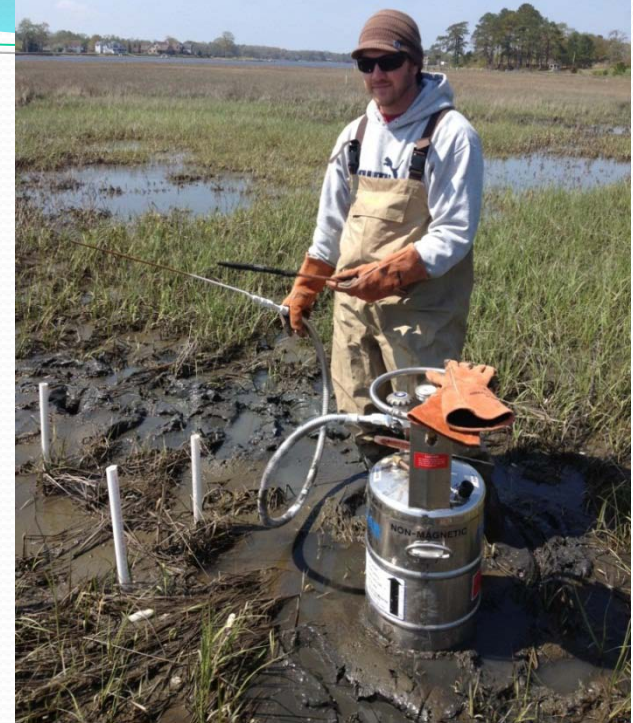
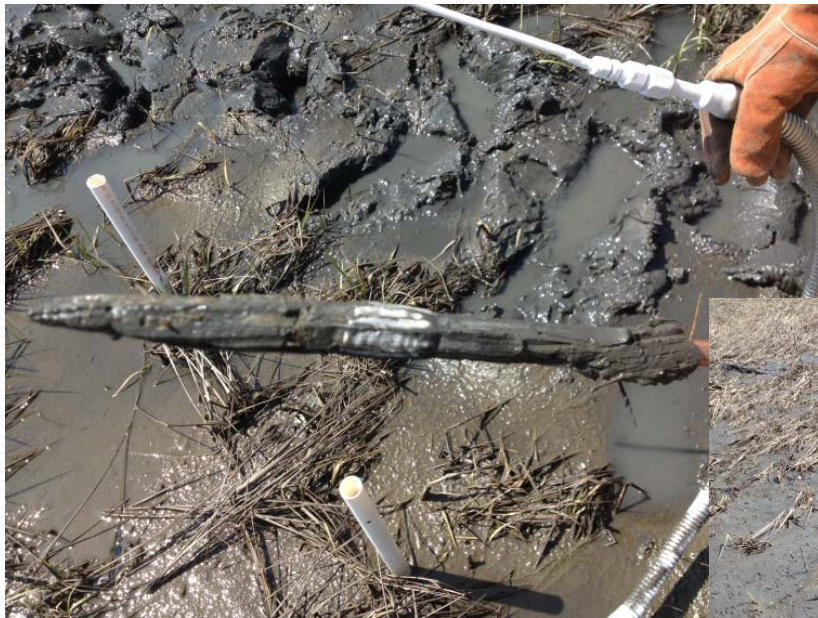
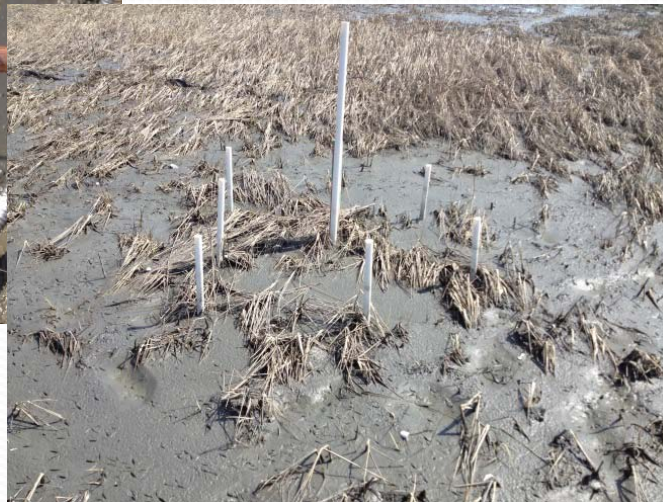
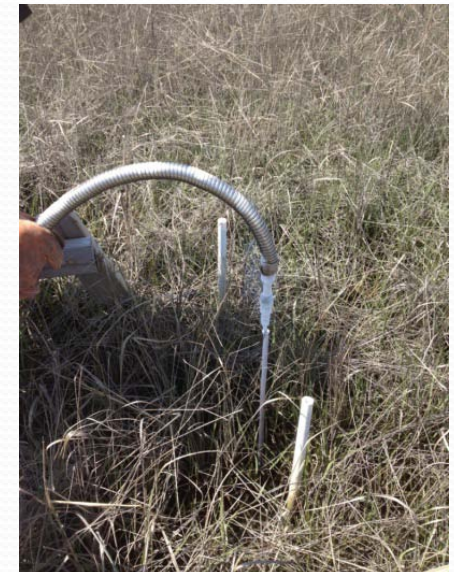
6. Cryogenic coring for feldspar horizon markers

measuring accretion thickness and movement
